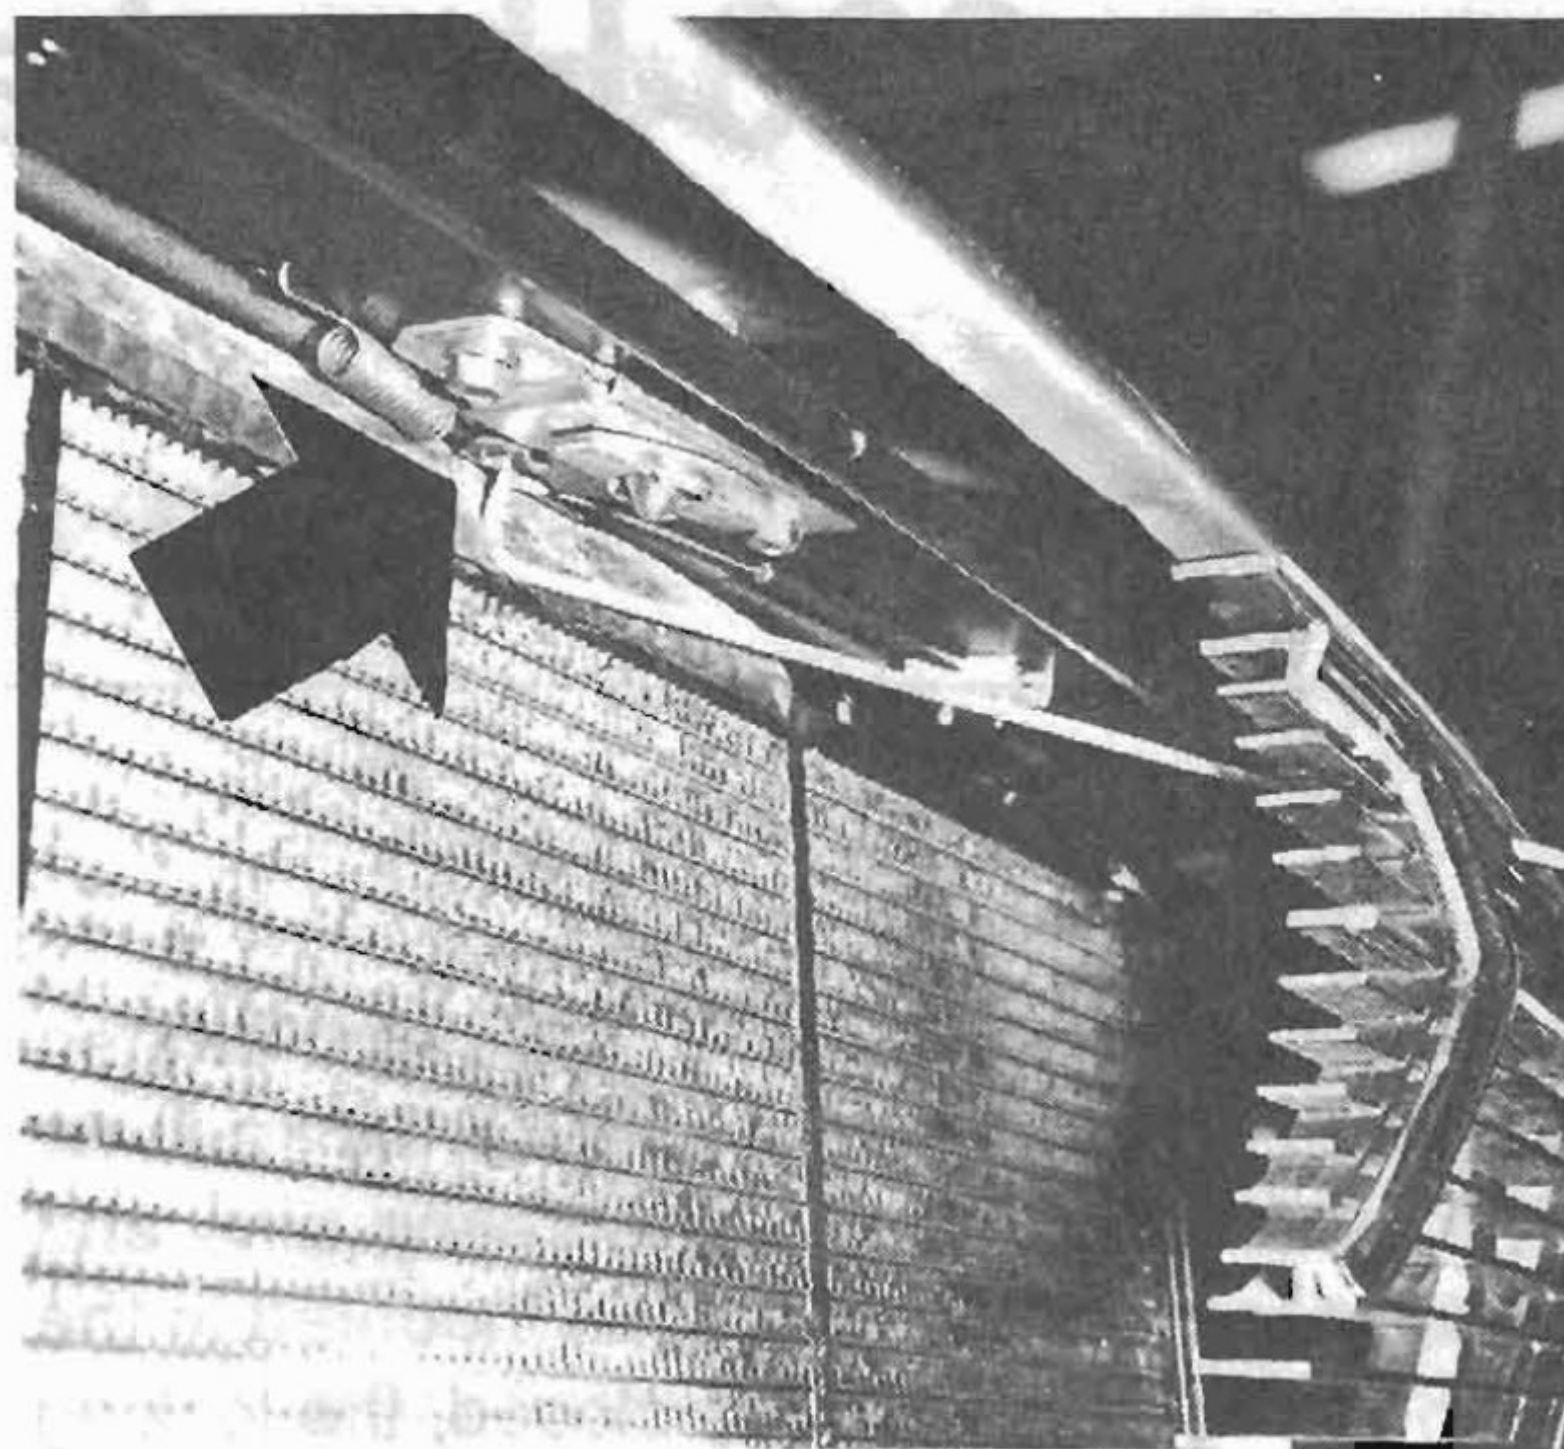
**Fig. 4.** Hood lock being released using special tool. C moved for clarity.
